MARINE

CORROSION

by Eric Ogden

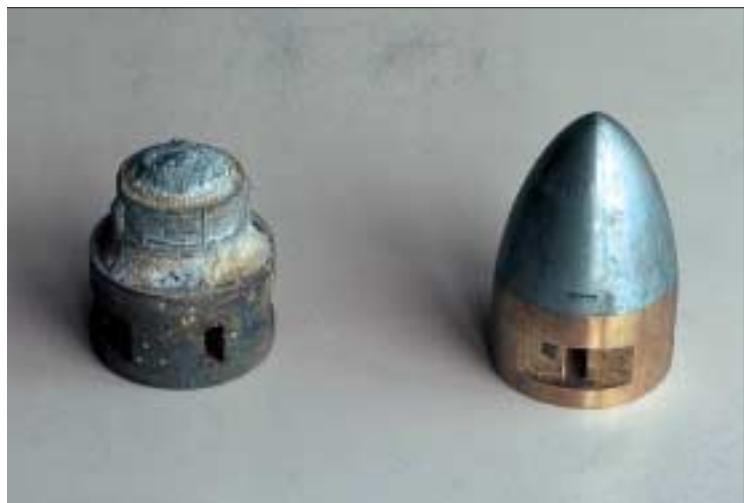
The anode on the left was eaten away in less than 8 days.

Two forms of cathodic protection are readily available to the modern yachtsman. The first is the common installation of sacrificial anodes at different places on the hull. They are usually made from zinc, a metal less resistant than most others to the effects of corrosion, and as a result we refer to these anodes as "zincs". This metal is used because it is anodic in comparison to all other materials used in naval construction. Its electronegative potential is from -1000 mV (see the table). Aluminium anodes are sometimes used on steel hulls because they

are lighter and less costly. On the other hand, for yachts used on inland waters it is recommended to protect them with magnesium anodes to take into account the variations of potential between salt and fresh water. Professional guidelines govern the precise placement and mounting of these anodes and they must be checked regularly as much for their deterioration as for the efficiency of their positioning. The number and the mass of the anodes must be adapted according to the size of the hull. Abnormally rapid deterioration indicates a problem that must be identified and corrected as soon as possible. It is strongly advised that all submerged metallic equip-

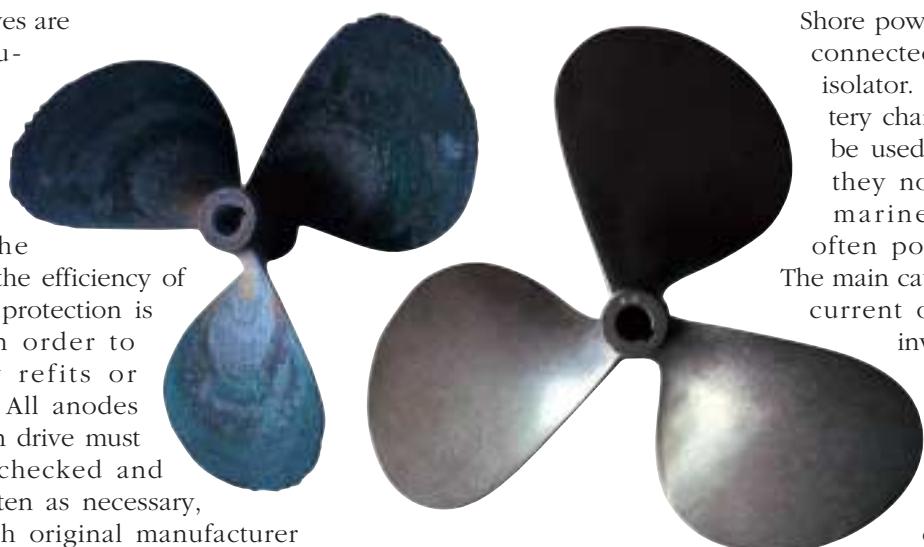
This propeller shaft suffered from DC stray current corrosion.

Electrolytic corrosion is not caused by a difference in potential between two dissimilar metals. It is due to leaks of direct or alternative currents, which artificially create a cathode and an anode sometimes even with the same metal. As in the case of galvanic corrosion, the metallic part or fitting will be wasted to the advantage of the cathode, but in this case, the damage will often be more severe and occur faster. Where the effects of galvanic corrosion can take months or years to appear, those of electrolytic corrosion will be visible after a few days or even a few hours in certain extreme cases.

conductor wiring running in the bilges, and poor or non-existent bonding of certain equipment. An electrical leak can be difficult to detect since the origin is usually well hidden. While it's not unusual to detect a leak in a poorly insulated bilge pump on one's own boat, what may be surprising is that the electrical currents that cause corrosion can originate from one or several neighboring boats or even the marina's power supply. In effect, all the boats connected to a dock-side terminal are interconnected via its ground connection. All the engines, and their propeller shafts are thus inter-connected and create one or several galvanic couples. The anodes fitted on certain boats then protect the propeller shafts and stern drives of other boats that do not have anodes or whose anodes are wasted.
